Haflinger Technik Ltd

Service Information

Repair of corroded MK2 CV Joints

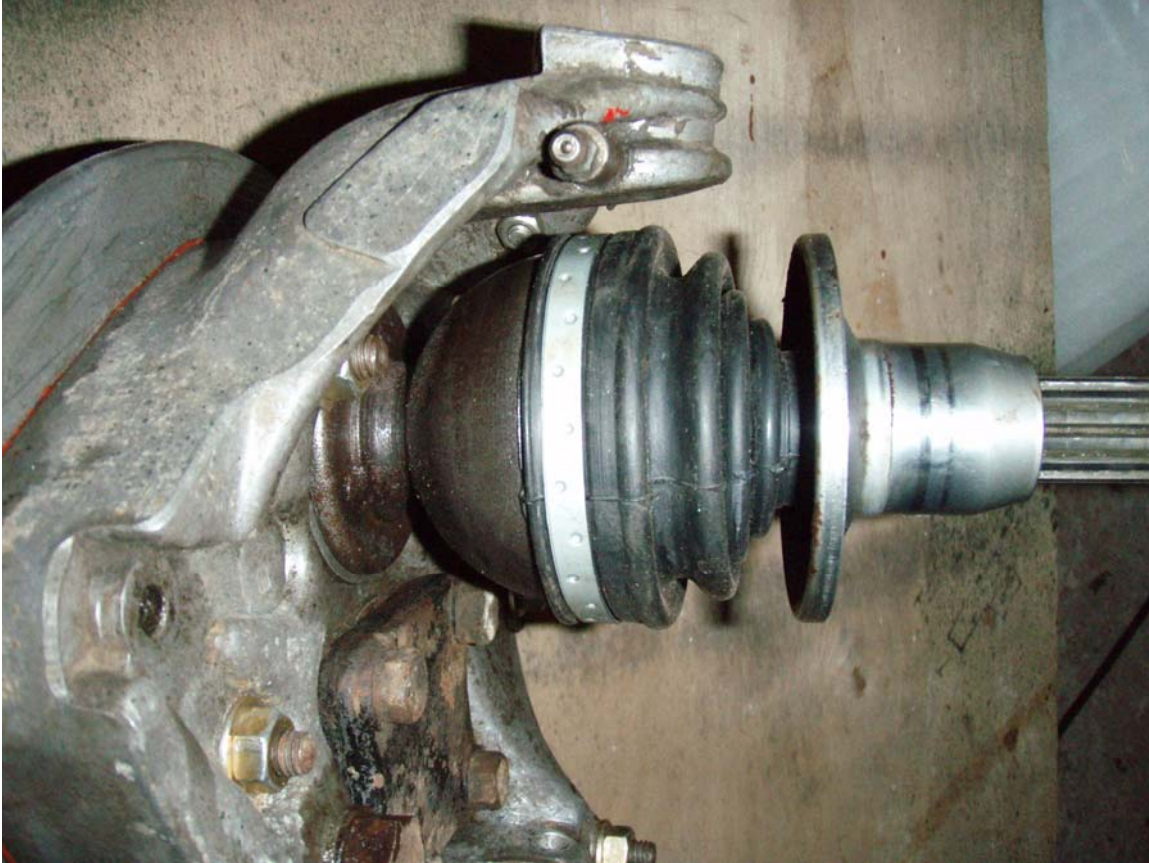
The following tip came from Andrew Edwards in Wales, who has come up with an interesting method of repairing a MK2 CV joint which was badly corroded on the ball.

Please find attached a photograph of the results of mating a Mk1 rubber gaiter with the Mk2 CV joint. The original ball was too pitted to seal properly as it looked like it had been left standing for some time. Otherwise it appears serviceable.

Remove the splash shield shown on the right of the photo. This is only held in place by an 'O' ring and comes off with a few sharp taps to its inner edge with a suitable blunt tool.

Next remove the cup/seal which the new gaiter is to replace. I found that I had to cut it off. An angle grinder is easiest with little chance of doing any damage to the hardened CV ball.

Now to cut a slot to coincide with the moulded ridge on the gaiter. To mark the slot location, turn the gaiter inside out so that the moulded ridge is visible. Using the line previously made to show the furthest the rubber fits over the ball, mark the location of the slot where it coincides with the raised rubber section. I then ran the lathe at a slow speed and used a fine permanent marker to continue the lines around the ball.

Cutting the slot proved difficult due to the ball being extremely hard. A tungsten carbide tip went blunt in no time. Eventually I ran the lathe in reverse and used a fine cutting disk on an angle grinder to work the slot to the correct size. Be sure to protect the bed of the lathe as the hot sparks created can do some damage. There is a small ridge around the swing arm part which located the original cup/seal. I also removed this to give a little more room for the rubber gaiter.

Next fit the new gaiter. Secure with the supplied metal ties. I am not sure if it sits exactly as it should as I have never seen the earlier gaiter in position, however it seems to work ok.
