Haflinger Technik Ltd

Service Information

December 2007

Repair of corroded MK2 CV Joints

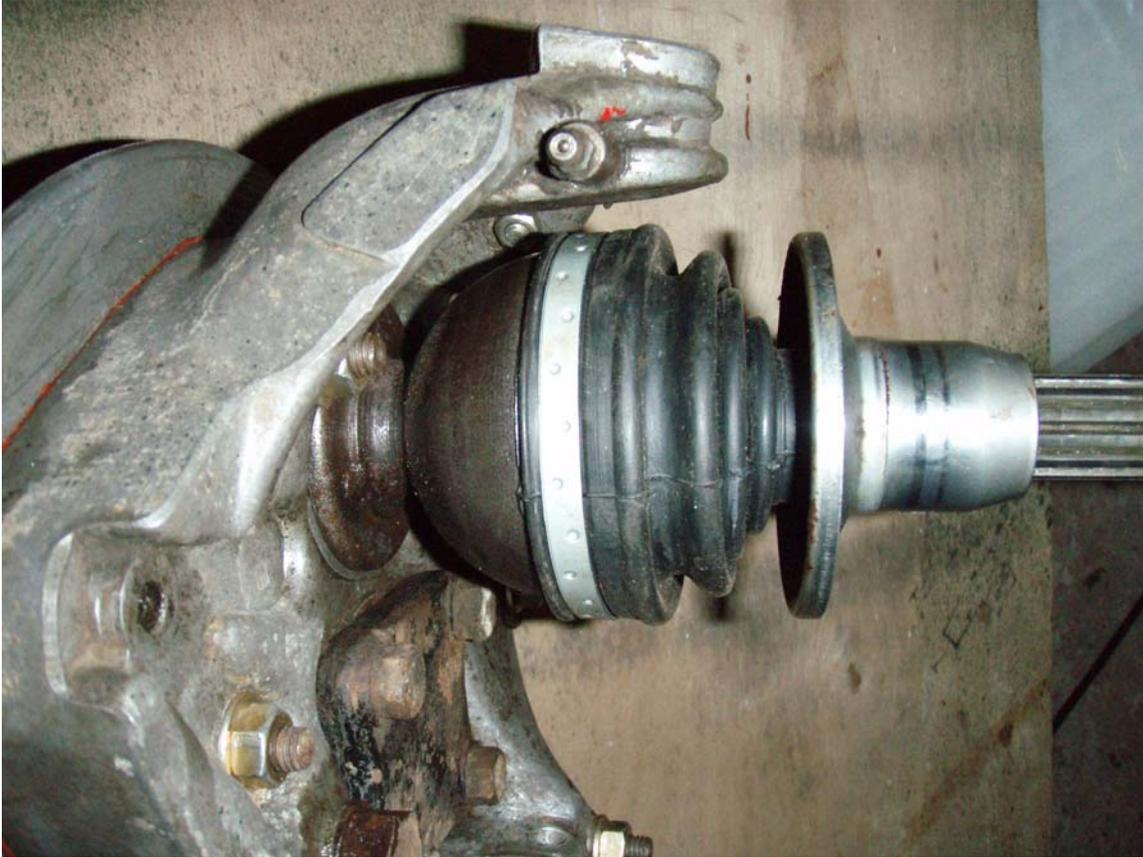
The following tip came from Andrew Edwards in Wales, who has come up with an interesting method of repairing a MK2 CV joint which was badly corroded on the ball.

Please find attached a photograph of the results of mating a Mk1 rubber gaiter with the Mk2 CV joint. The original ball was too pitted to seal properly as it looked like it had been left standing for some time. Otherwise it appears serviceable.

In short, he has modified the MK2 joint to take the rubber gaiter from a MK1 type joint !

Remove the splash shield shown on the right of the photo. This is only held in place by an 'O' ring and comes off with a few sharp taps to its inner edge with a suitable blunt tool.

Next remove the cup/seal which the new gaiter is to replace. I found that I had to cut it off. An angle grinder is easiest with little chance of doing any damage to the hardened CV ball.

Now to cut a slot to coincide with the moulded ridge on the gaiter. To mark the slot location, turn the gaiter inside out so that the moulded ridge is visible. Using the line previously made to show the furthest the rubber fits over the ball, mark the location of the slot where it coincides with the raised rubber section. I then ran the lathe at a slow speed and used a fine permanent marker to continue the lines around the ball.

Cutting the slot proved difficult due to the ball being extremely hard. A tungsten carbide tip went blunt in no time. Eventually I ran the lathe in reverse and used a fine cutting disk on an angle grinder to work the slot to the correct size. Be sure to protect the bed of the lathe as the hot sparks created can do some damage. There is a small ridge around the swing arm part which located the original cup/seal. I also removed this to give a little more room for the rubber gaiter.

Next fit the new gaiter. Secure with the supplied metal ties. I am not sure if it sits exactly as it should as I have never seen the earlier gaiter in position, however it seems to work ok.
